PROJECT REFERENCE

Parkway Shopping Centre

Parkway SC, Coulby Newham

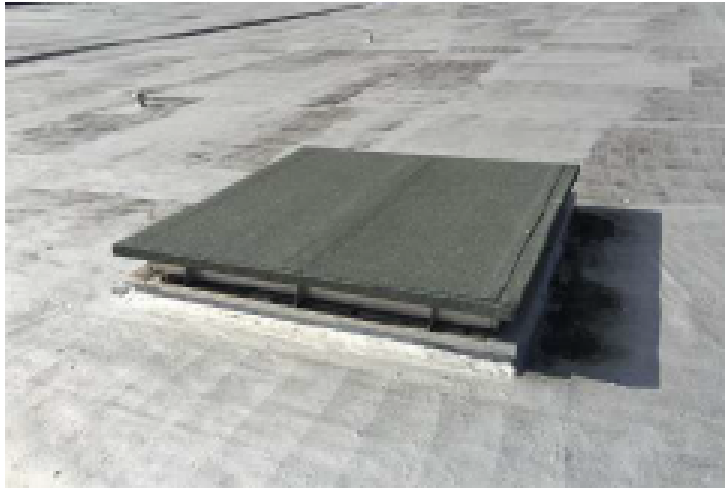
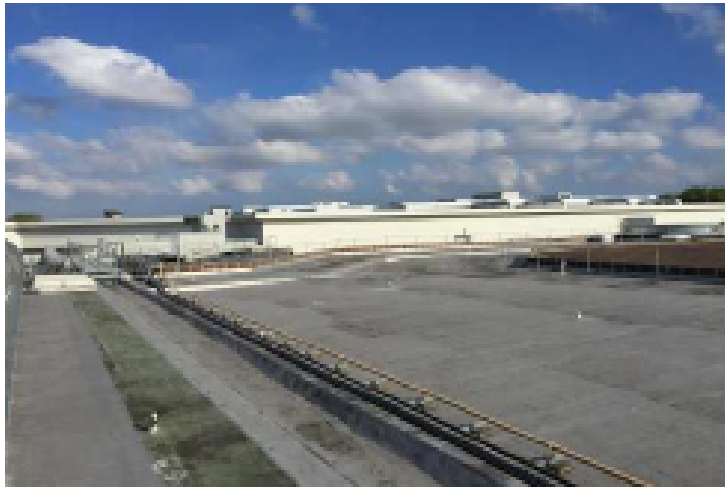
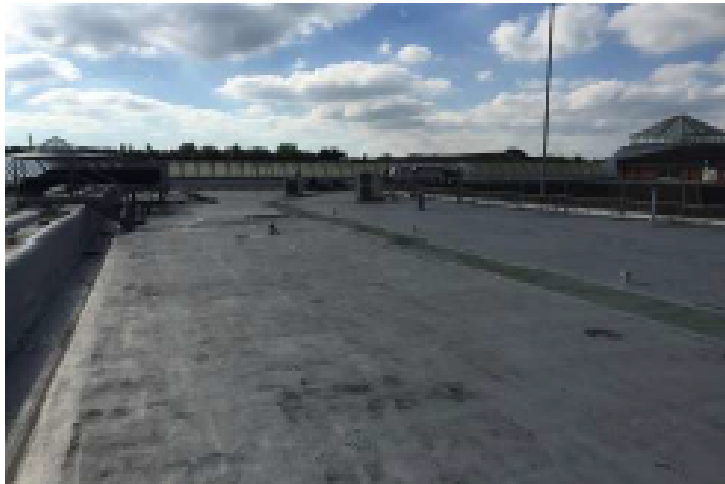
Before Images

Moy Materials were invited to site in order to provide a Roof Condition Survey and Refurbishment Specification to alleviate water ingress issues to an aged built-up bitumen felt covered roof.

This system carried a 20 year single point warranty for all areas waterproofed. The final specification called for a failed hessian-fleece-reinforced system to be removed and the underlying bitumen felt waterproofing to be repaired where required, with only saturated sections of the existing build-up requiring to be stripped and replaced, prior to the installation of our 2 layer Imper Paralon waterproofing system. Gutters were encapsulated with our cold-applied liquid system, Enkopur.

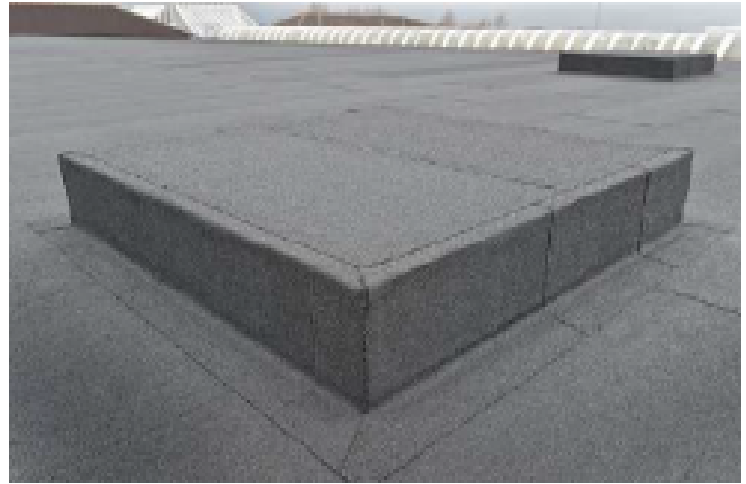
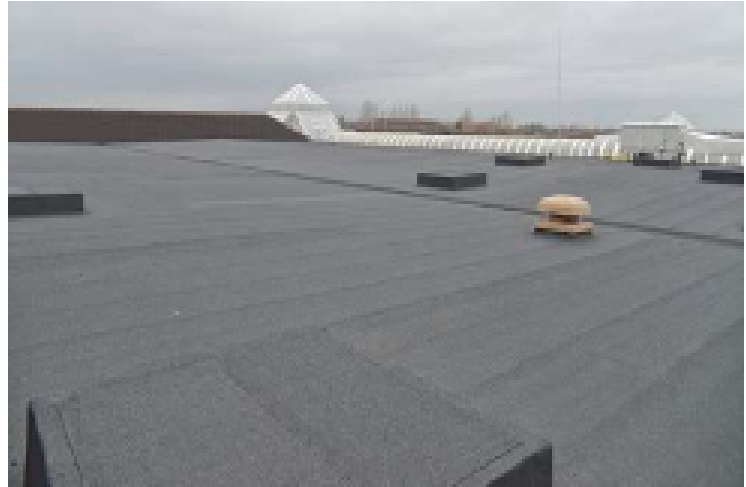
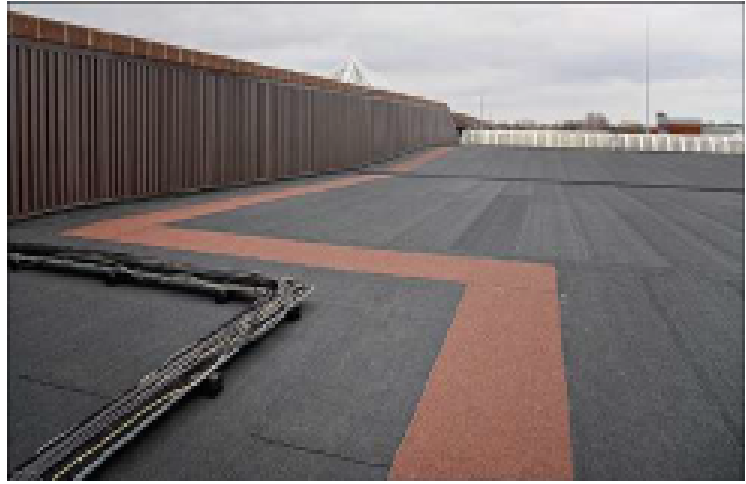
After Images

The attention to detail on this project was exemplary and put an end to the client's long-standing problems with water ingress.
